Technical Bulletin

No: 501 – Head RF Amplifier Shielding

Reference Units Shipped After 5/1/1993

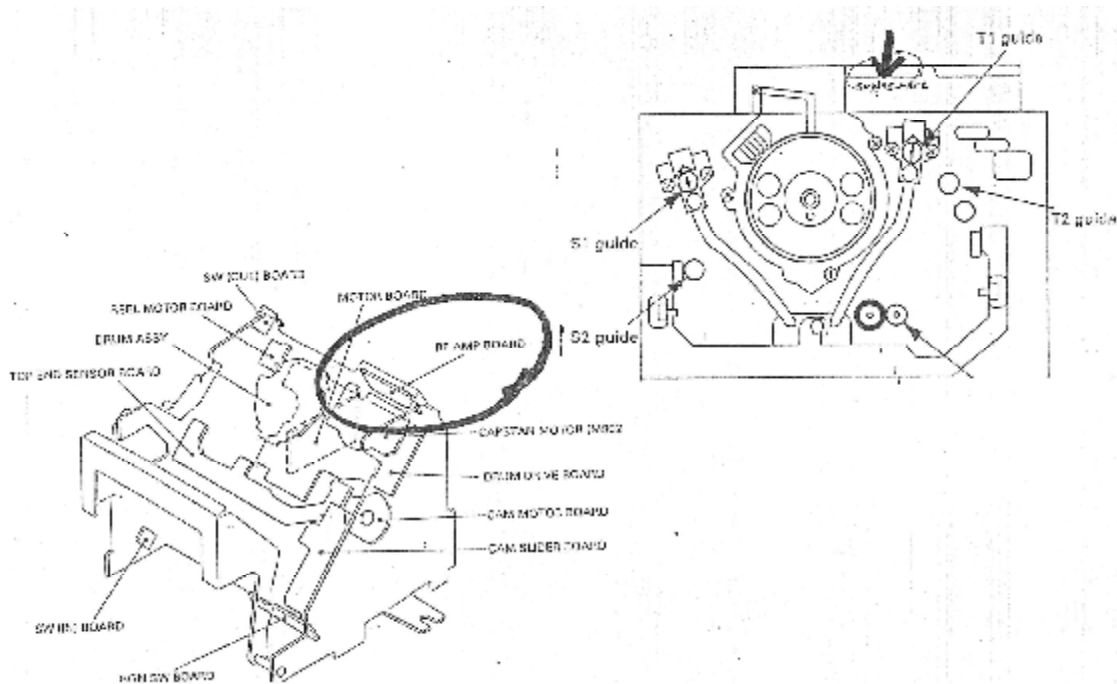
A poor mechanical connection between the head amplifier housing and the chassis that supports it can result in poor shielding of this amplifier. Symptoms of this problem include:

1. Unit sporadically rewinds from pause
2. Unit goes into play rather than pause on cue up
3. High error rates
4. Problems on tape threading

To fix this problem in the field, use a soldering iron (60 watts or more) to apply a bead of solder between the metal head housing and the chassis in the area shown on the diagram below. Insure a good solder flow between the metal parts.

This area is easily located and accessible just to the right of the head assembly by removing the lid of the DAT machine.
