Technical Bulletin

No: 712 – Conversion of TR-20 from 520 kHz to 1610 kHz

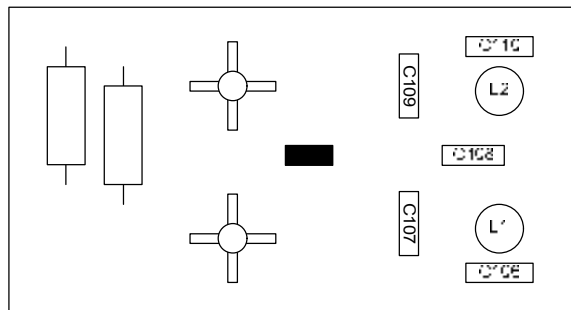
1. Replace Harmonic Filter Components on Amplifier Board.

LOCATION	ORIGINAL VALUE	NEW VALUE
C106	3600 pF (P/N 2883)	2000 pF (P/N 2890)
C107	1000 pF (P/N 2882)	220 pF (P/N 2891)
C108	5600 pF (P/N 2884)	3300 pF (P/N 2885)
C109	3300 pF (P/N 2885)	750 pF (P/N 2892)
C110	2200 pF (P/N 2886)	1500 pF (P/N 2791)
L1	36 turns (P/N 2876)	23 turns (P/N 2880)
L2	24 turns (P/N 2877)	19 turns (P/N 2881)

Replace the two inductors and 5 capacitors with the values shown. On the new indicators, scrape away **JUST ENOUGH** varnish to wrap around the turret posts on the PC board. Scraping too much can cause a short to the ground plane! Secure the coils to the PC board with silicone RTV sealant.
