Technical Bulletin

No: 1001 – 4x4a Audio Present LED

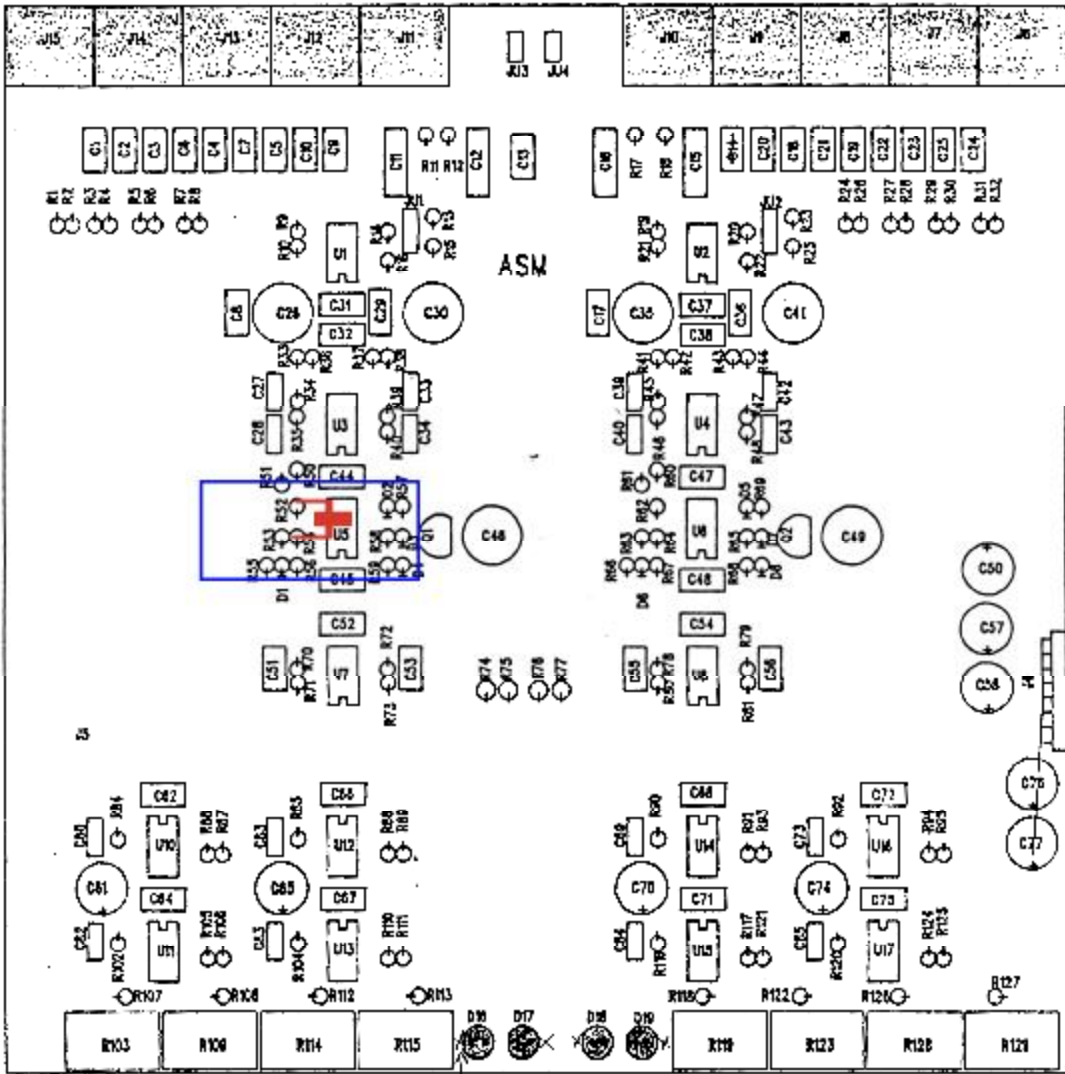
Symptom: The green audio present LED's illuminate continuously when connected to a Radio System's digital console.

Solution: Solder a .01uf film capacitor (RS Part #5860) across R54 on both the slave (RS Part #11080) board and Power (RS Part #11078) Board. *

*2x4a Only
